Proceedings of 59th Annual Associated Schools  
of Construction International Conference

# Historic Building Case Study: Measuring Differential Settlement Combined with Experiential Learning

**Kyle Larson, Ph.D., P.E. and Steve Schaffner**  
Kansas State University  
Manhattan, Kansas

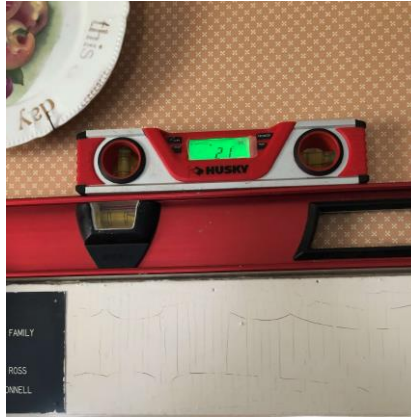
Figure 1. Plumbness of header above doorway

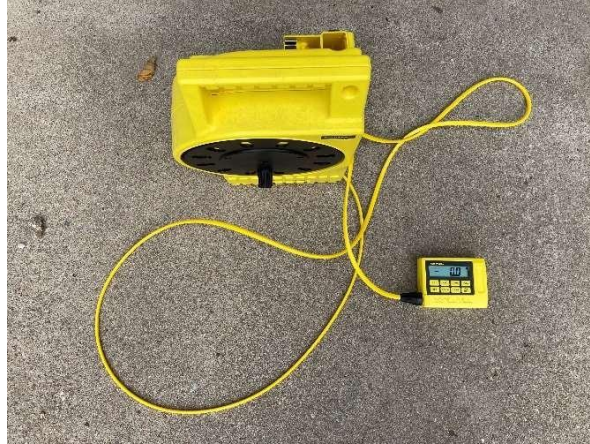
The authors decided the best way to measure any settlement would be with a zip level. A zip level is a high precision pressurized hydrostatic altimeter (Corporation 2022), Figure 2. Spot elevations can

Figure 2. Zip level used for elevation change measurements

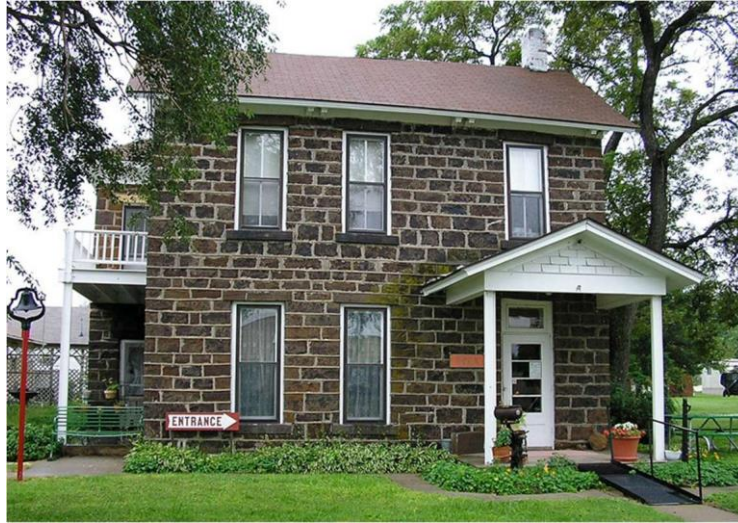
Figure 3. Hodgen House on North East elevation

The Hodgen House was built in 1876 with many additions that were to follow over the next few years. The original structure of the house is a two-story wood frame building that sits upon a rock foundation along with a stonework exterior which was later added around 1878. In 1879, a one-story addition was built along the East backside of the house which consisted of two additional rooms to the house. The following year in 1880, there was a second floor constructed above the East addition that included another two rooms to the household. In 1882, a two-story addition was constructed on the West backside that included four more additional rooms. Aside from other improvements to the house that come in later years, approximately six years of construction transpired to develop the full structure of the house as it is today.

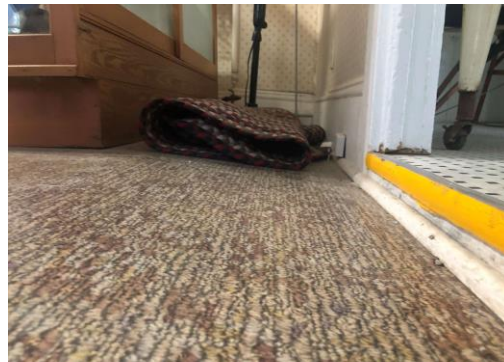
The Hodgen House was first visited on September 28th, 2021 and the initial observations noted were cracks found on a few walls as well as the slopping and sagging floors seen throughout the house. Figure 4 shows the typical sagging floor at room entry thresholds.

Figure 4. Typical floor conditions
