Experimental Study on Flexural Behavior of Reinforced Concrete Beams Corroded by Chloride Ion

Experimental study on flexural behavior of reinforced concrete beams corroded by chloride ion

Trung Hieu Nguyen¹, Van Quang Nguyen¹, Phuoc Lanh Le¹, Manh Hung Nguyen¹

¹ National University of Civil Engineering, Hanoi, Viet nam
hieunt@nuce.edu.vn

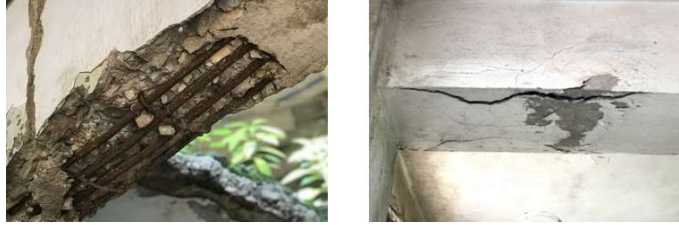
Fig. 1 illustrates the typical failure of a RC beams. The increasing volume of reinforcement during the corrosion process causes the fracture of the concrete cover. The corrosion might happen in a part of the cross-section (the edge of column) or a total of that. It is possible to recognize the general point of RC structures failure caused by steel corrosion is the reduction of concrete's cross-section and reinforcement's cross-section, the decreased bonding capacity between reinforcement and concrete, which leads to decreased load-bearing of that cross-section [1][2][3].

Fig. 1. Corrosion deterioration of RC beams

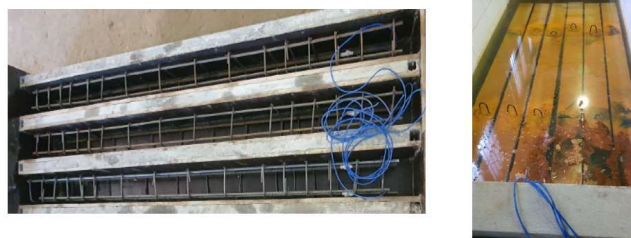
After 28 days of curing, the D-2 beam was put into a tank with a certain amount of sodium chloride (NaCl) solution at a mass concentration of 5 %, as shown in Fig. 3. Twenty-four hours later, direct current was used in the electrochemically-accelerated corrosion test with the current density setting at 400 $\mu\text{A}/\text{cm}^2$. According to Faraday's Law, the corrosion time corresponding to a certain targeted corrosion ratio can be determined as following formula:

Fig. 3. Electrochemically-accelerated corrosion test

where i is the current density set at 400 $\mu\text{A}/\text{cm}^2$ based on a the existing investigations [1][2][5], R is the target corrosion ratio, M is molar mass of Fe, that is, 56 g/mol, γ is rebar radius, F is Faraday constant, which is 96487 C/mol, ρ is the iron's density which is 7.8 g/cm³, and t is theoretical duration of corrosion. With the target corrosion ratio of 10 %, based on Farraday's Law, the calculated corrosion time with 560 hours.

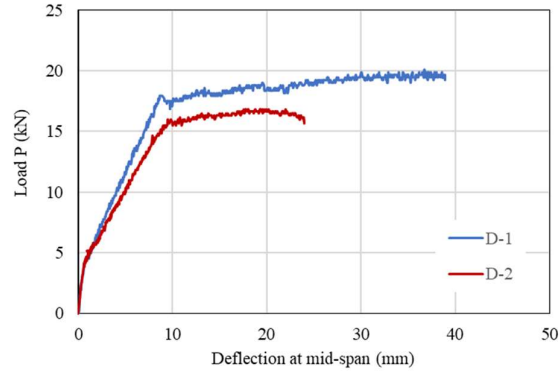
Fig.7 shows the load-deflection relationships while Table 2 presents the ultimate capacities and deflection characteristics of two beams D-1 and D-2 obtained from flexural test. It can be seen that there are three different behavioral zones on each curve. The first zone represents the stiffness of the uncracked beam D-1 and initial corrosion cracked beam D-2. The first visible crack loads were determined based on a first change in slope of the load–deflection curve. It can be seen that in this initial stage of loading, all specimens show almost the same stiffness. This has shown that the effect of steel corrosion is not significant when the magnitude of applied load is small.

The second zone represents the stiffness of the cracked section. For corroded beam D-2, the slope of the load-deflection curve was lower than that of the corresponding reference specimen D-1. The obtained results presented in Fig. 7 shows that the yield load (generally seen as a second change in slope of the load– deflection curve) of D-1 were higher than that of the corroded beam D-2. The third zone corresponds to a damaged beam with wide crack, yielding reinforcement and crushing of concrete in compressive zone. As shown in Fig. 7 and Table 2, the ultimate load carrying capacity of the control beam D-1 was significantly higher than that of the corroded beam D-2. Regarding the ductility of RC beams, the obtained results of deflection at the ultimate load, the obtained results showed a significant decrease in the case of reinforcement corrosion.

Fig. 7. Load – deflection curves of two beam specimens

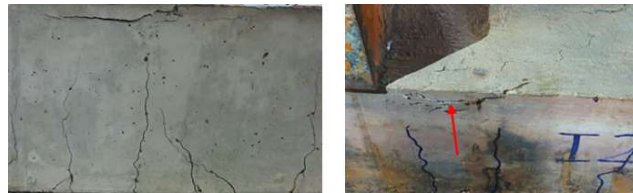
The mode of failure of the control beam and corroded beam were present in Fig. 8. All tested beams failed by yielding of steel reinforcement followed by crushing of concrete in compressive zone.

Fig. 8. Failure mode of D-1 and D-2 beams

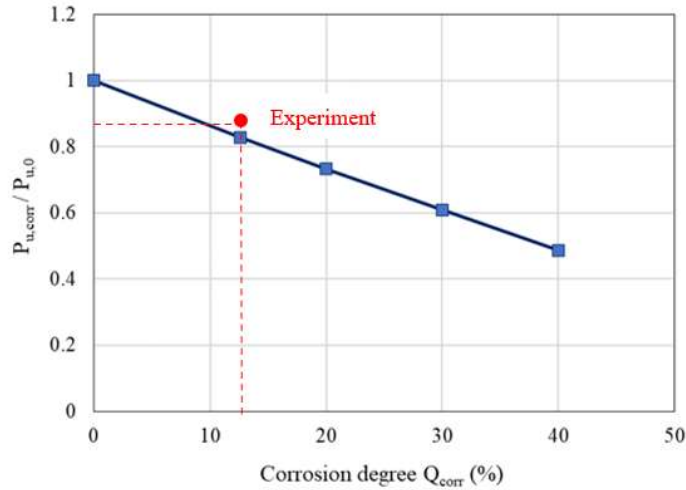
Fig. 10. Residual ultimate load of corroded RC beam D-2

Fig. 10 illustrates the residual ultimate force of corroded beam D-2 in which the vertical axis shows the ratio of the ultimate force of corroded and non-corroded beam section $P_{u,corr} / P_{u,0}$. Fig.10 indicates that the residual ultimate force of corroded beam

significantly decreased with an increase of the degree of corrosion. In comparison the predicted residual capacity with the experimental results at the corrosion degree of 12.6 %, it can be seen that the prediction value is consistent.
